# Manhole Inspection Summary

Manhole # S57A\_\_003MH

Insp Date: **6/25/08 10:36 AM**

**Location** Address: **157 n haven st**

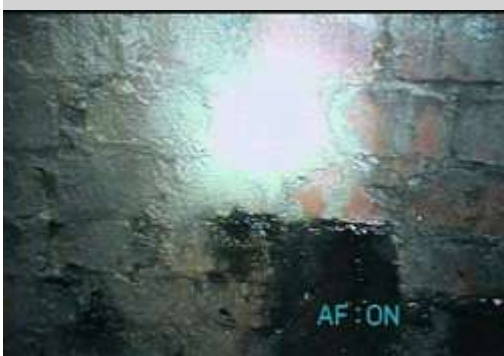
Defect 3

**Barrel** Material: **Brick** ☐ Parged

Infiltration: ☐ None ☐ Joint ☐ Cracks ☒ **Mortar** ☐ Roots ☐ Wall

infiltration in barrel

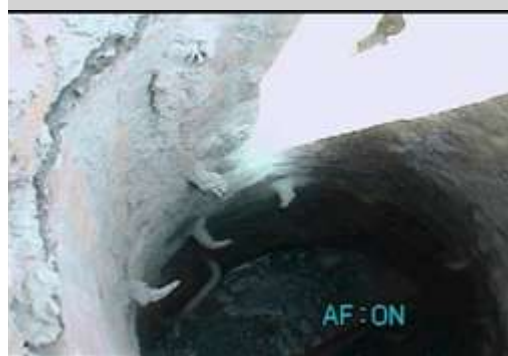
Defect 2

Infiltration: ☐ None ☐ Joint ☐ Cracks ☐ Mortar ☐ Roots ☒ **Wall**

**Steps** Count: **4** Missing: **3** ☒ **Corroded**

corroded steps; corbel infiltration

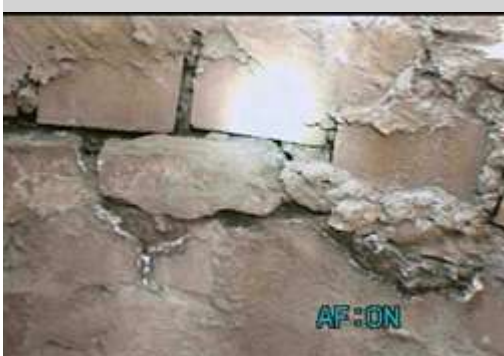
Defect 1

Condition: ☐ Sound ☐ Cracked ☐ Root Intrusion ☐ Loose Brick ☒ **Deteriorated**

Infiltration: ☐ None ☐ Joint ☐ Cracks ☒ **Mortar** ☐ Roots ☐ Wall

frame adj; Chimney deteriorated and missing mortar

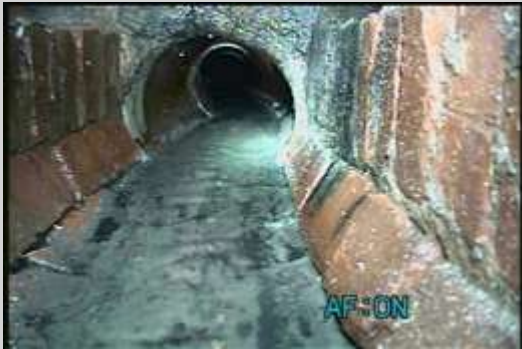
12 O'Clock Outflow

8 in. Circular Gravity Sewer  
Pipe Out @ 12 O'Clock

Invert Depth: **8.60** (ft.) Flow Characteristics: **Slow**

Infiltration: **None** Pipe Seal Cond: **Unknown**

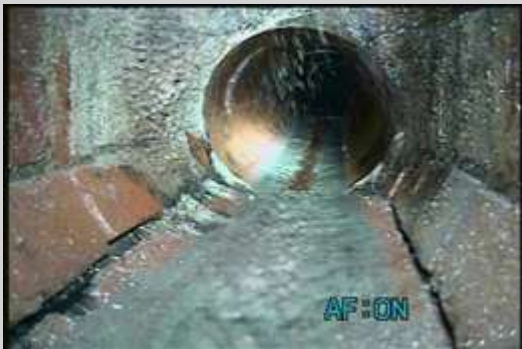
6 O'Clock Inflow

8 in. Circular Gravity Sewer  
Pipe In @ 6 O'Clock

Invert Depth: **8.59** (ft.) Flow Characteristics: **Slow**

Infiltration: **None** Pipe Seal Cond: **Unknown**
